Silver Creek Park Restoration Plan

City of Manitowoc, Wisconsin

Stantec Project: 193709009

December 28, 2022

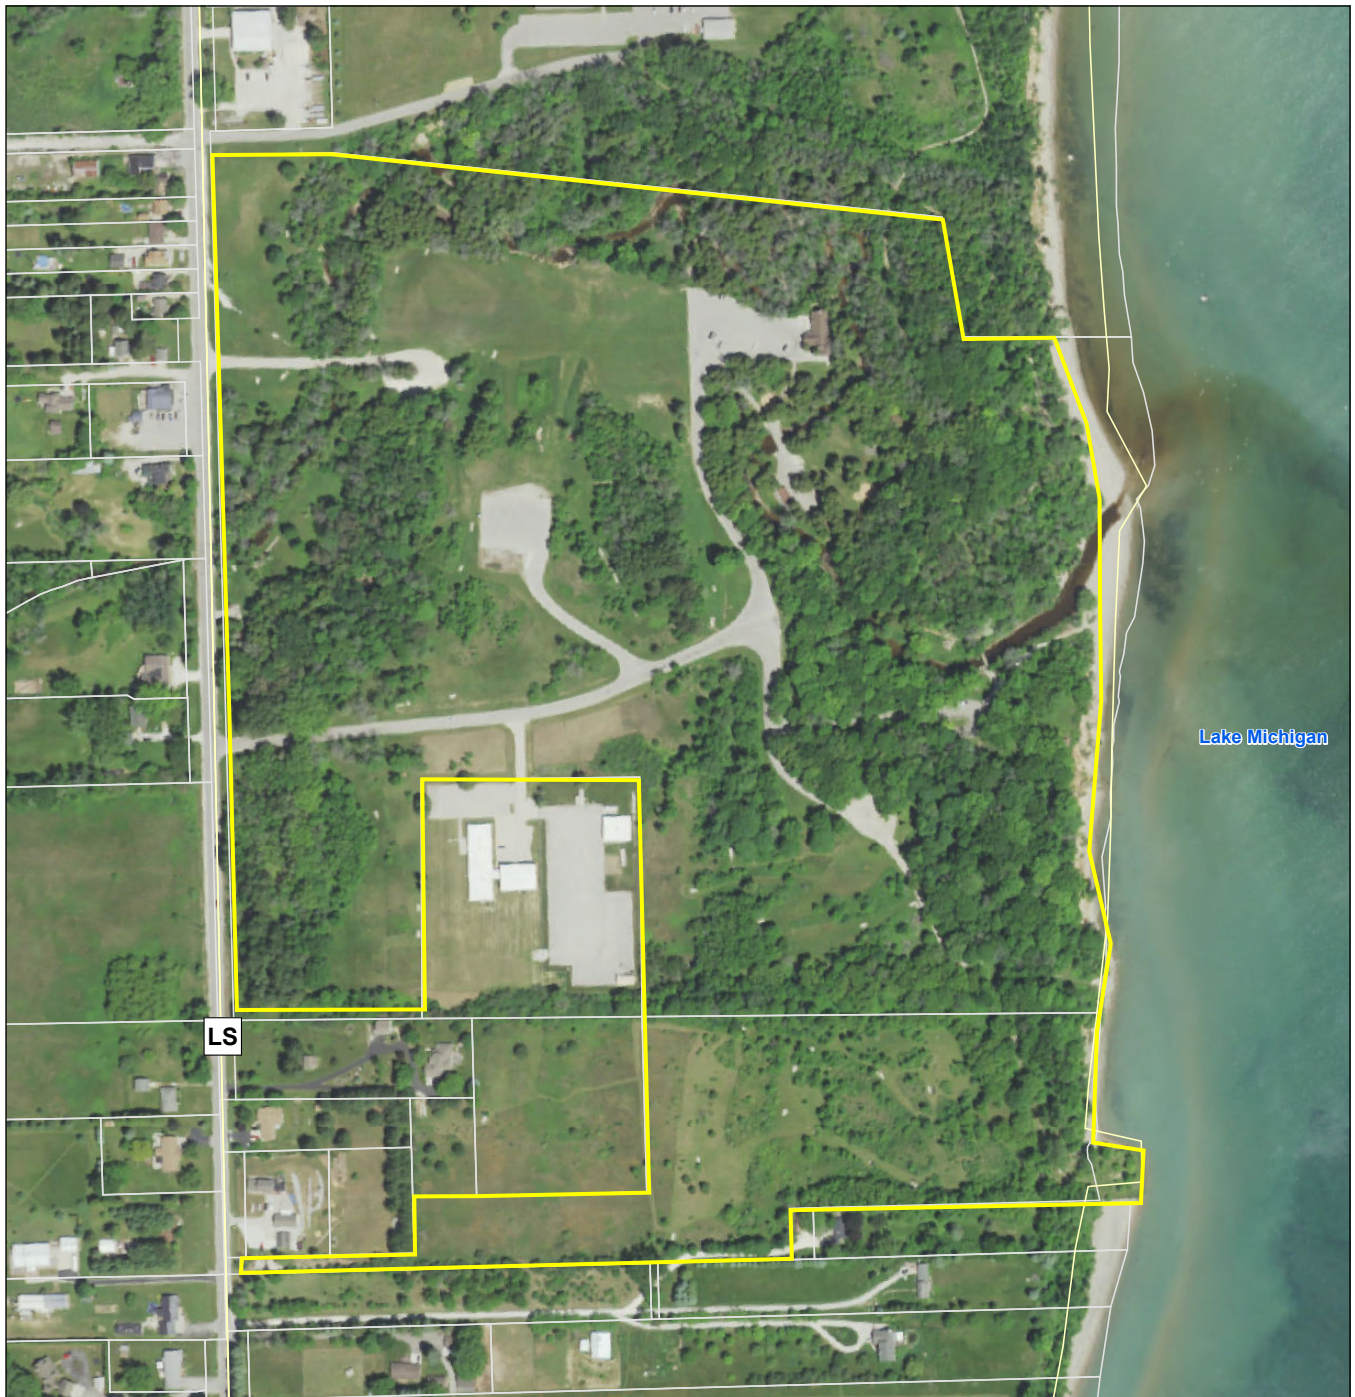
Figure No.
1
Title
Project Location

Current land cover within the Project site includes steeply sloped bluffs adjacent to Lake Michigan, northern mesic hardwood and conifer forests, upland meadow, shrub thickets, and maintained lawn (Figure 1, Appendix A). Silver Creek bisects the Park, flowing from west to east into Lake Michigan, and provides important foraging and spawning habitat for a variety of fish species. The Silver Creek lakeshore, including the estuary of Silver Creek at Lake Michigan, has been identified as one of the most significant migratory stopover habitats on Lake Michigan for waterfowl in particular (WDNR 2019). Over 10,000 waterfowl use the site annually, and 130 bird species have been observed to use the site during migration, which provides a diversity of insects and fish for foraging, and meadow, shrub, and deciduous and coniferous forest cover. Significant streambank and bluff erosion is occurring within the Park, resulting in unstable and unsafe banks which release significant sediment loads to Lake Michigan.

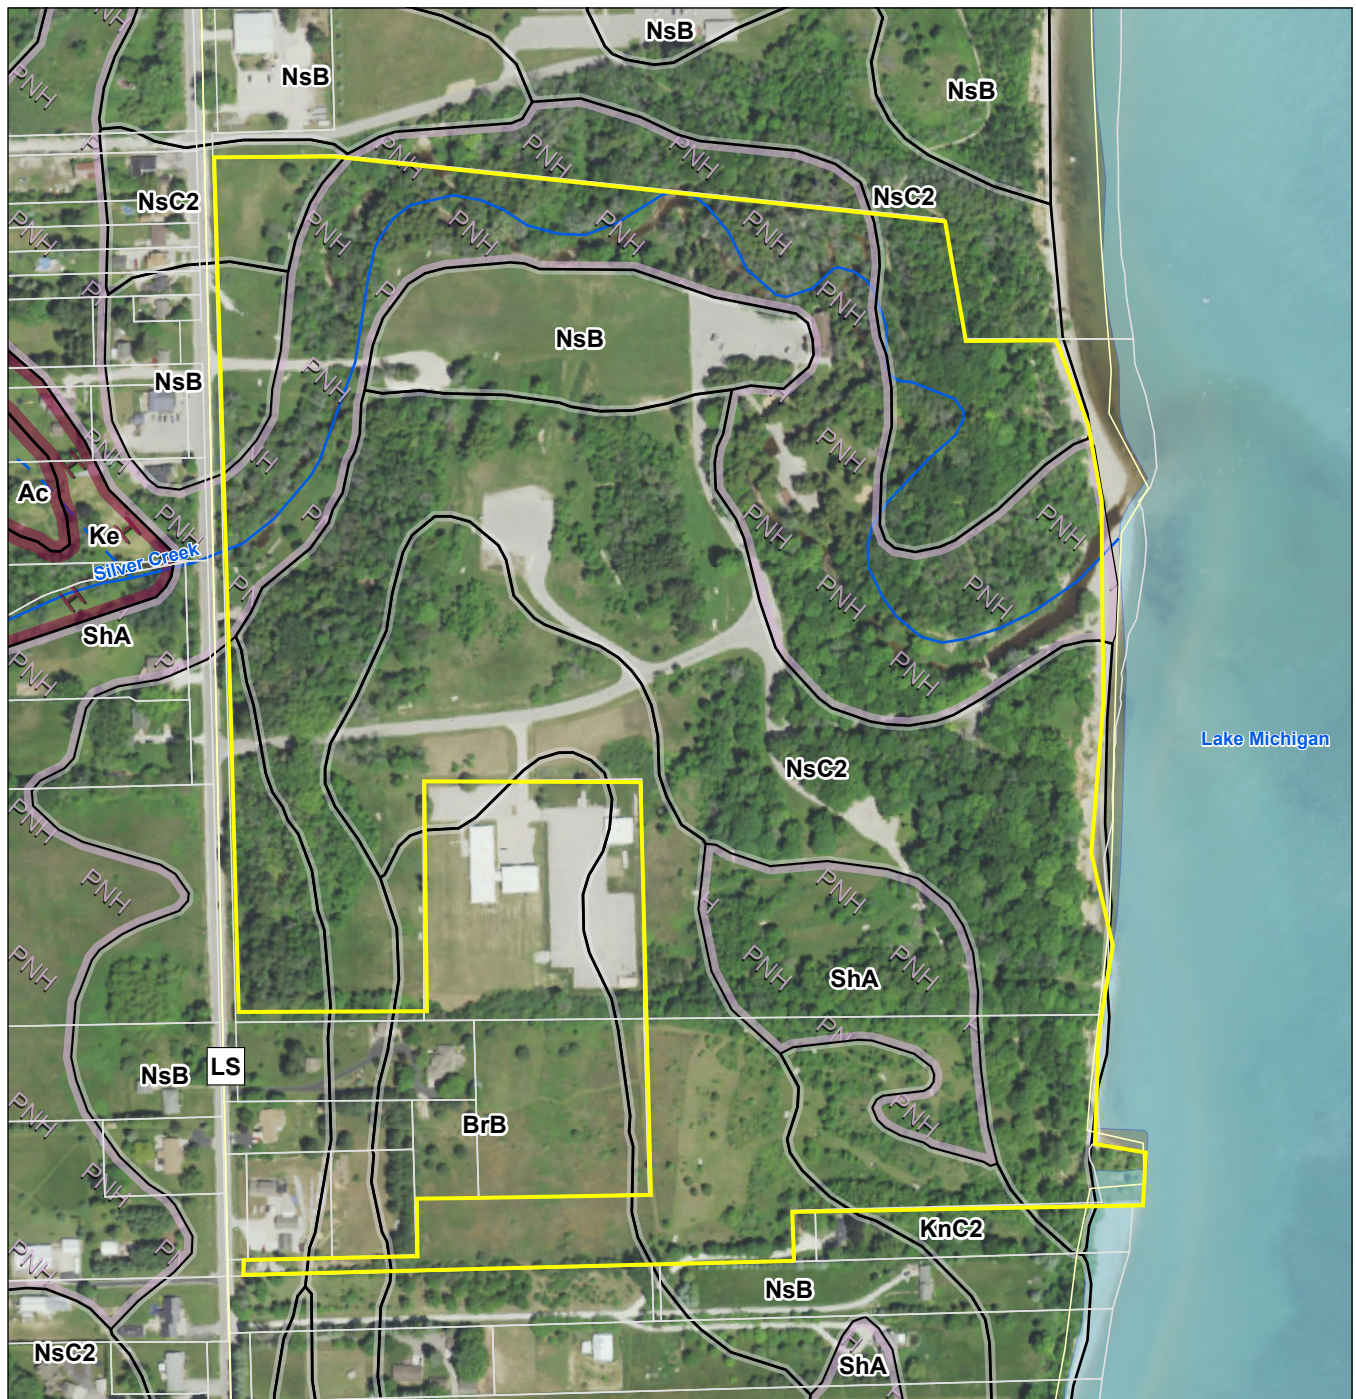
Figure No.
2

Natural Resources Conservation Service (NRCS) soil mapping for the Project area is provided in Figure 2. Soils are primarily sandy loams to fine sandy loams which represent glacial till layers. Typically, these till layers are well-stratified along the Lake Michigan bluff slopes, and may vary to include clayey silts, gravel, and larger stone depending upon the dynamic series of erosion processes at any given location.

Title
NRCS Soil Survey Data
Hydric Ratings

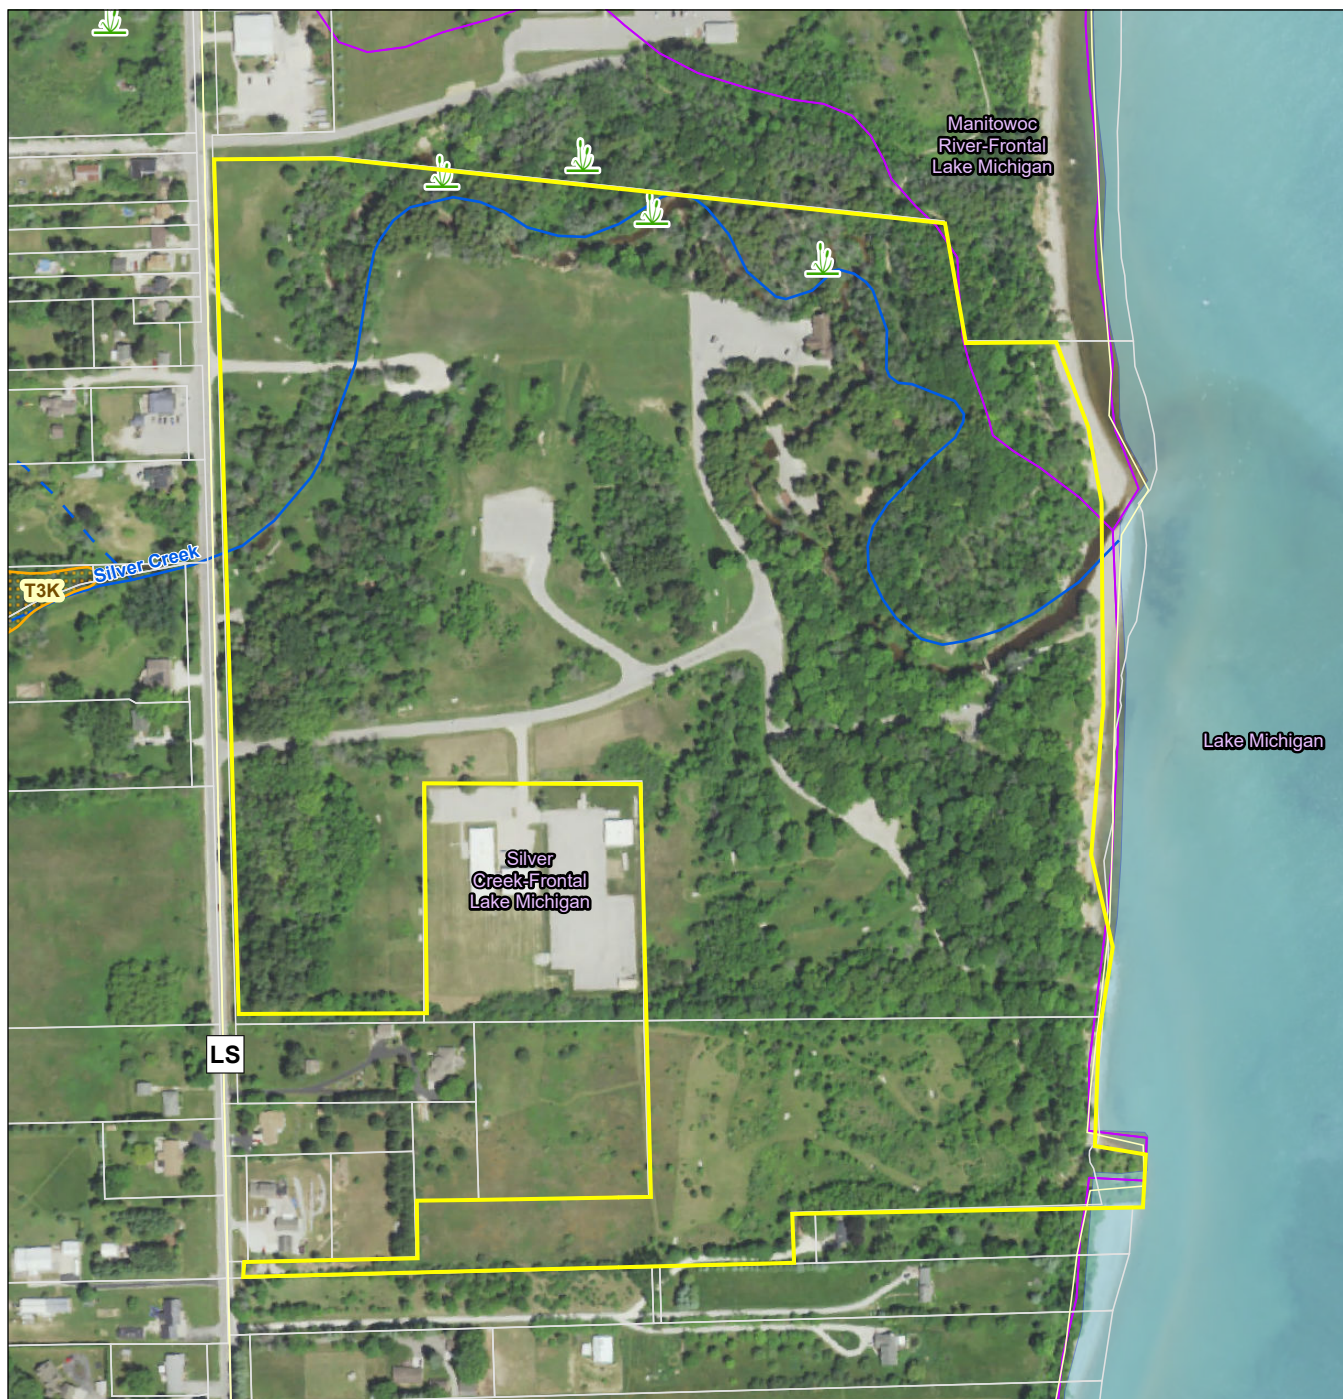
Figure No.
3

The northeast portion of Silver Creek Park is located in the Lower Manitowoc River watershed and the south portion is located in the Seven Mile and Silver Creek Basin watershed (Figure 3). Silver Creek bisects the Park, flowing west to east into Lake Michigan. Silver Creek is listed as one of Wisconsin's 2022 impaired waters (303d list). Silver Creek impairments are unknown; however, pollutants include Total Phosphorus, and WDNR assessments have indicated that Silver Creek suffers from degraded water quality impacted by industrial, commercial, and agricultural land uses upstream. The lower portion of Silver Creek has a diverse fishery (WDNR 2001).

WI Wetland Inventory and Watersheds (HUC-10)

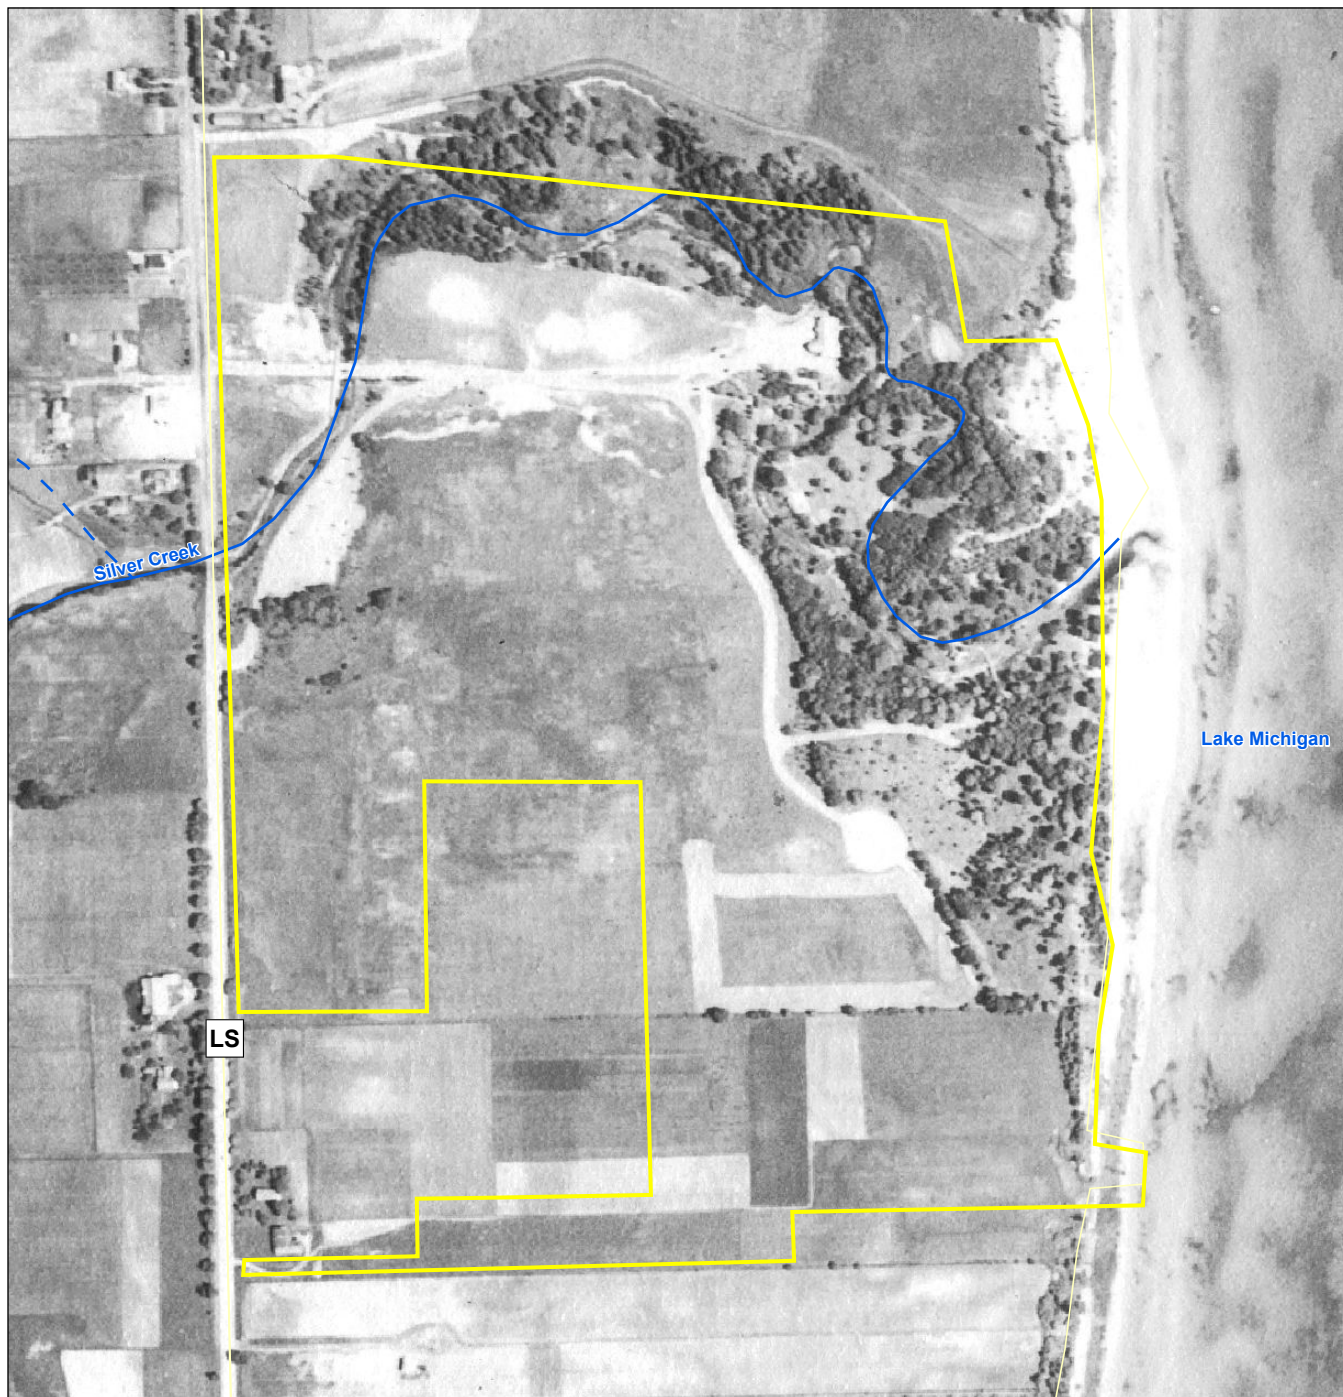
Figure No.
4

Title
**USDA Aerial Photography
July 4, 1938**

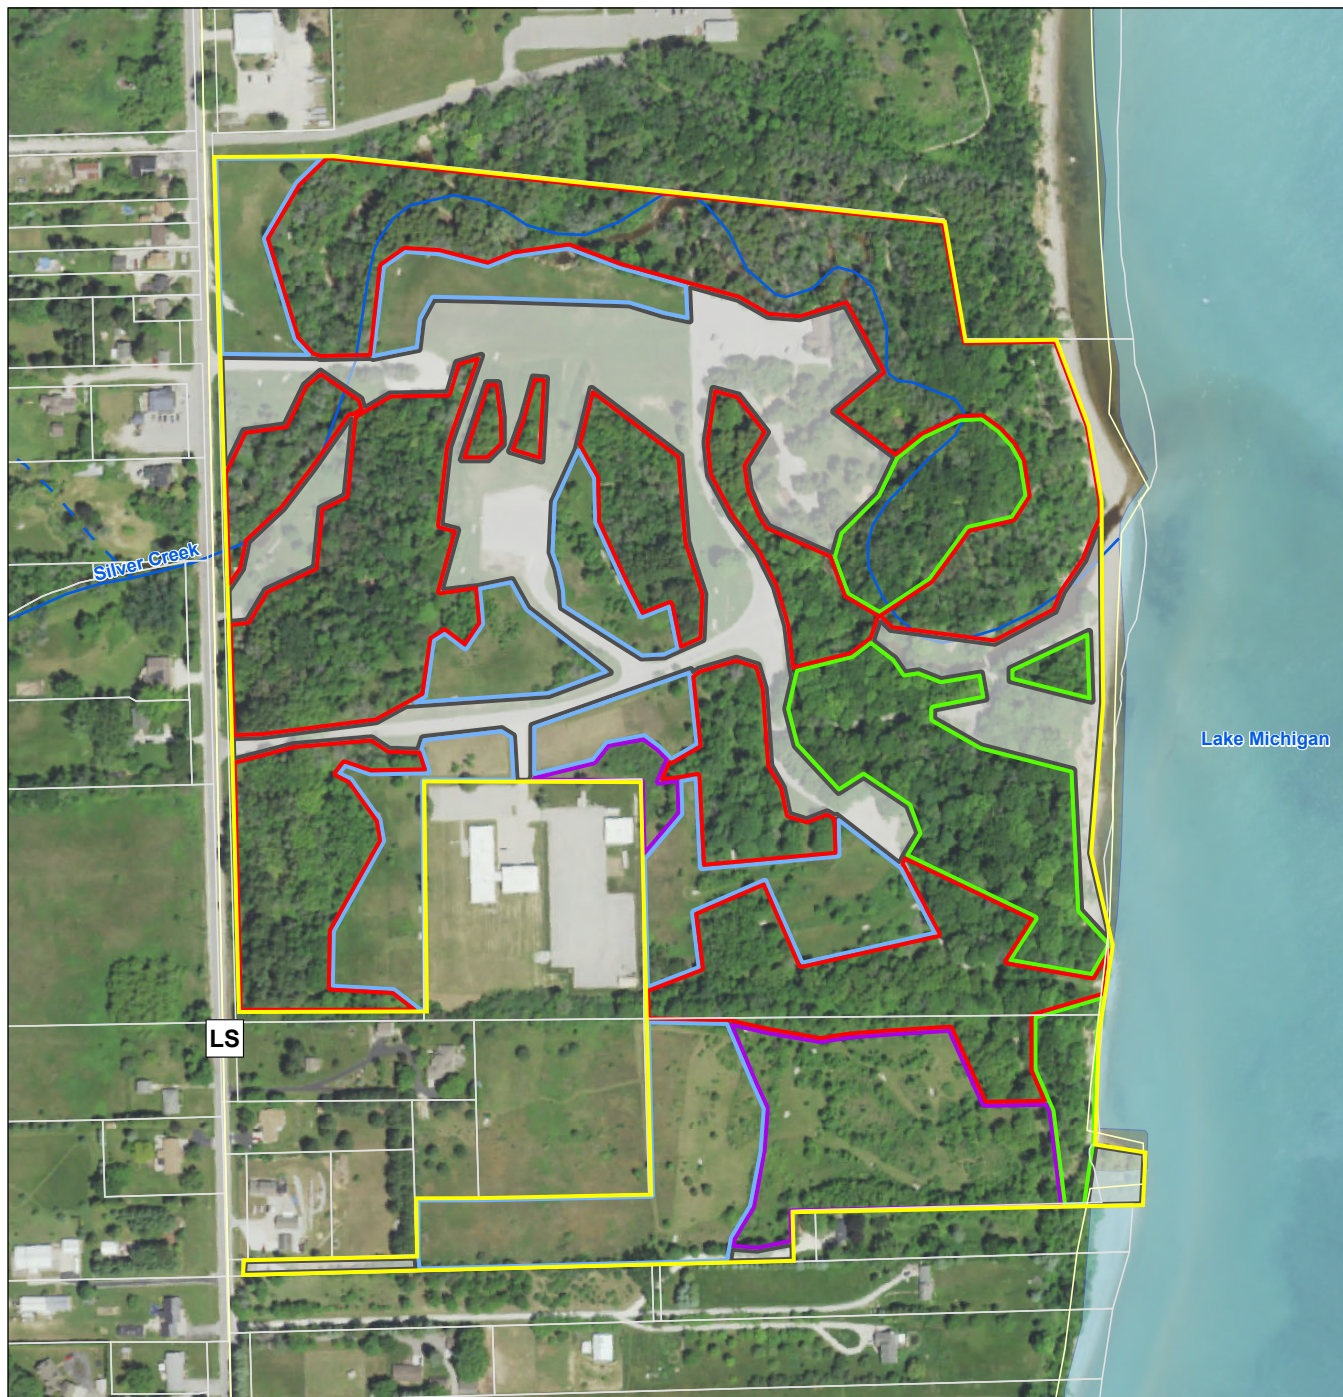
Figure No.
5
Title

Restoration implementation planning recommendations are provided for defined restoration units, with more details provided in the following sections. The plan will be implemented in phases, by management zones aligned to existing plant community types, observed conditions, restoration goals and objectives, and anticipated level of effort. Recommended restoration approaches will be developed into detailed work plans in coordination with the City, partner non-profits and professional restoration ecologists, and incorporating volunteer support and anticipated funding availability. Proposed restoration units are depicted on Figure 5.

- Project Area (76.22 ac)
- Parcel Boundary
- Proposed Restoration Units**
- Degraded Forest Restoration (31.32 ac)
- Mesic Forest Enhancement (7.98 ac)
- Pollinator Meadow Enhancement (14.98 ac)
- Shrub Community Enhancement (5.45 ac)
- Maintained as Turfgrass, Developed Facilities (16.49 ac)

Proposed Restoration Units
